**EXPERIMENTAL MAINTENANCE PAINTING
ON THE I-64 RIVERSIDE EXPRESSWAY
IN LOUISVILLE**

**Research Report
KTC-00-10**

June 2000

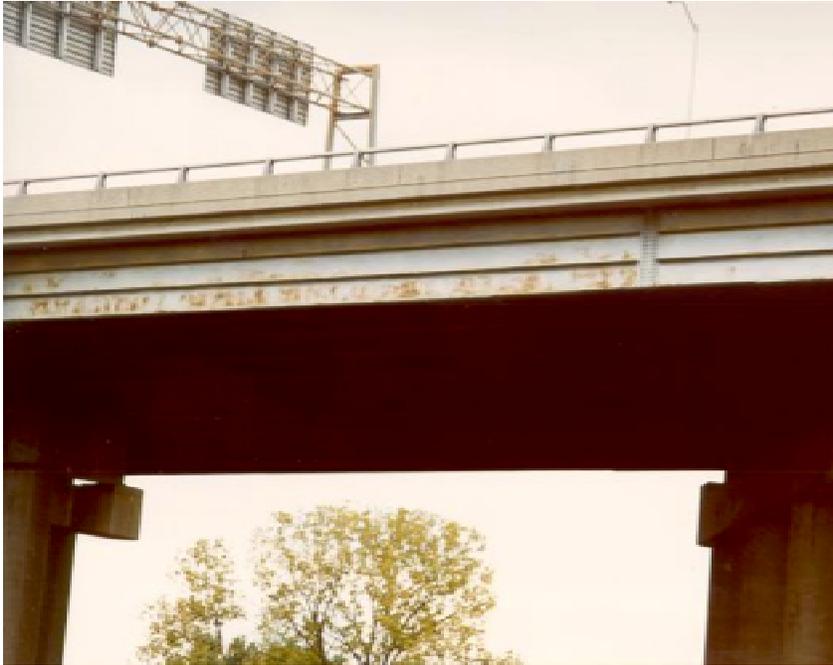
Figure 5. Span 13 showing weathering of aluminum alkyd exposed red lead primer in 1995.

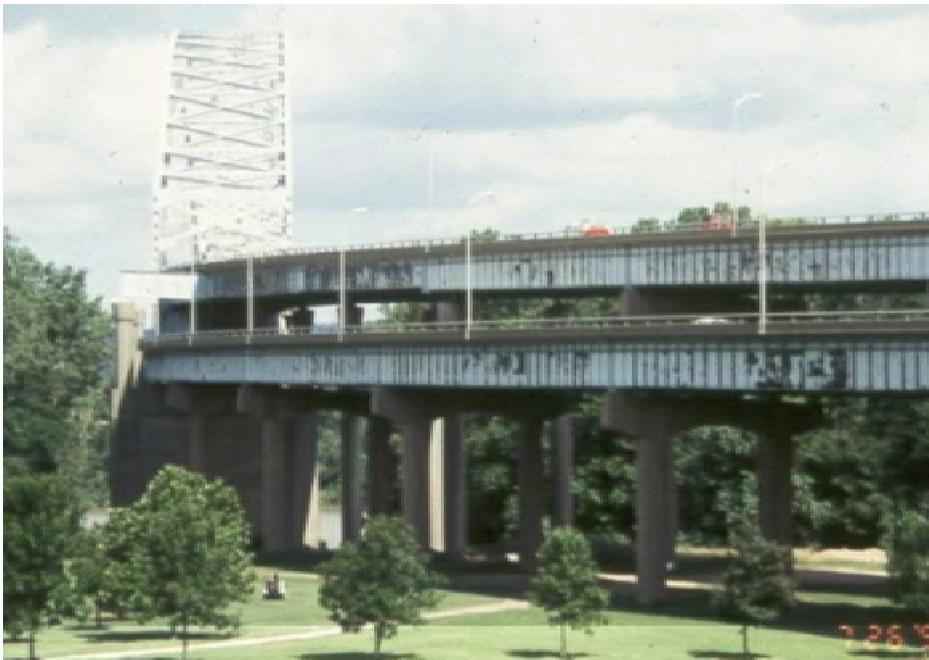
In 1995, the KYTC Paint Team began work on preparing special notes for the maintenance painting of the Parkway structures. Preliminary inspections of those structures revealed the existing paint contained lead. Most of the existing paint was in relatively good condition with erosion due to weathering. Extensive corrosion was observed on steel under open deck joints in spans 1 and 2. The existing paint on span 14, which had been previously overcoated, was in poor condition and was disbonding throughout the span.

Figure 6. Span 14 showing extensive disbonding of existing coating in 1995.

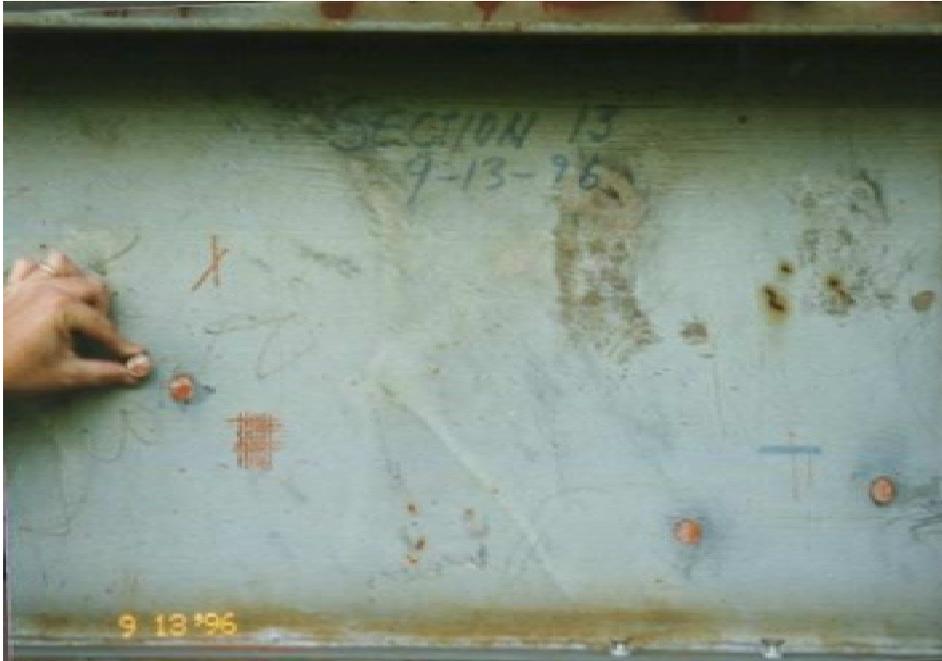
Figure 7. Pull-off and tape adhesion testing of existing paint on span 13.

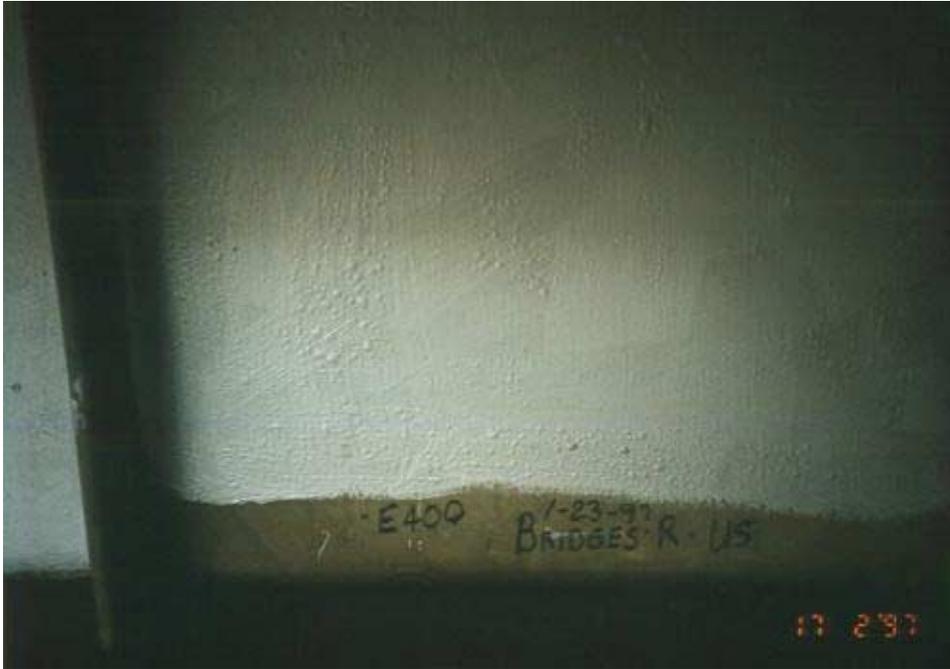
Figure 17. A test patch where an experimental paint blistered.

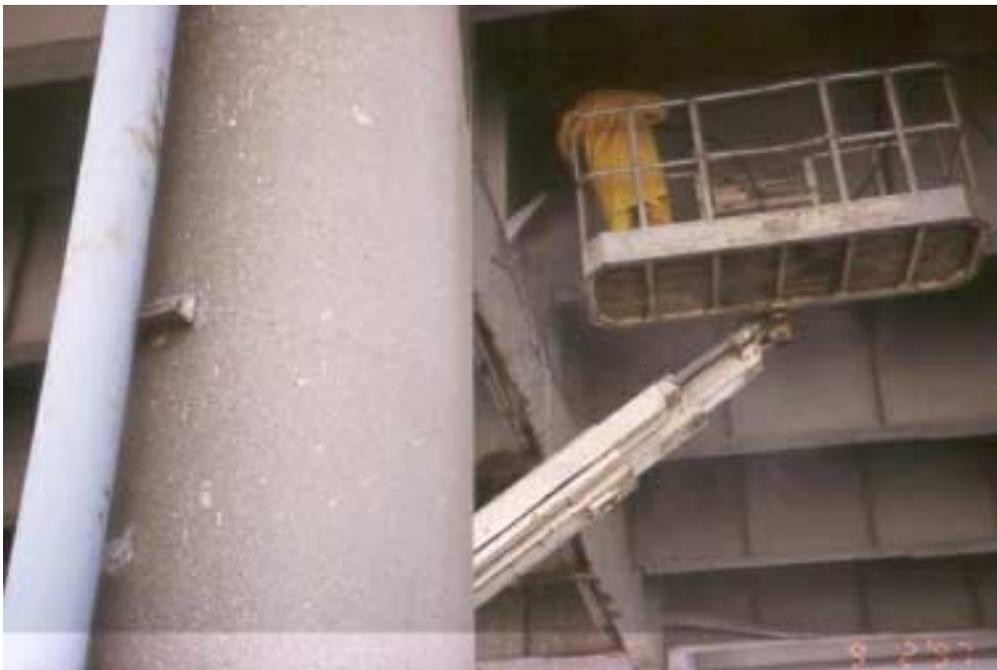
Figure 22. Pressure washing on span 1 in 1997.

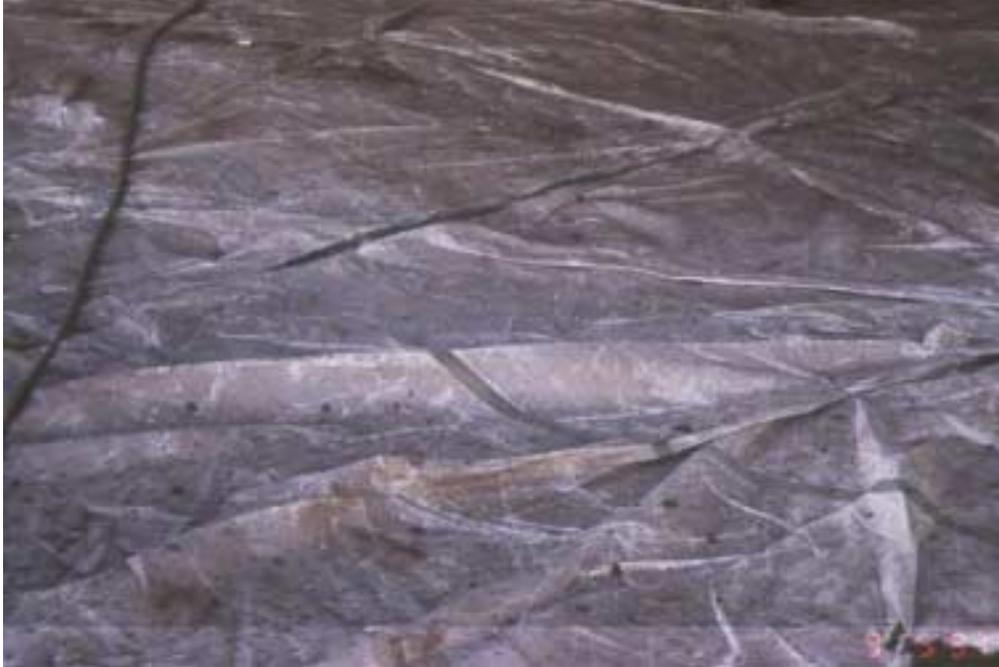
Riverfront development work ran under and around span 1 (2,073 feet of plate-girder structures/3,458tons of steel). Span 2 (2,745 feet of plate-girder structures/3,838 tons of steel) was contiguous with span 1. A portion of River Road running under span 2 was closed for reconstruction of the 1st Street on-ramp. At those locations, the 85 percent containment screen was placed on the ground to filter the wash water and catch all paint chips generated during pressure washing (Figures 22-24). Workers used man-lifts to access the elevated steel. Paint chips generated during washing were captured on the grounded screens and collected daily by vacuuming (Figure 25).

Figure 25. 85 percent drop cloths placed on the ground to collect debris.

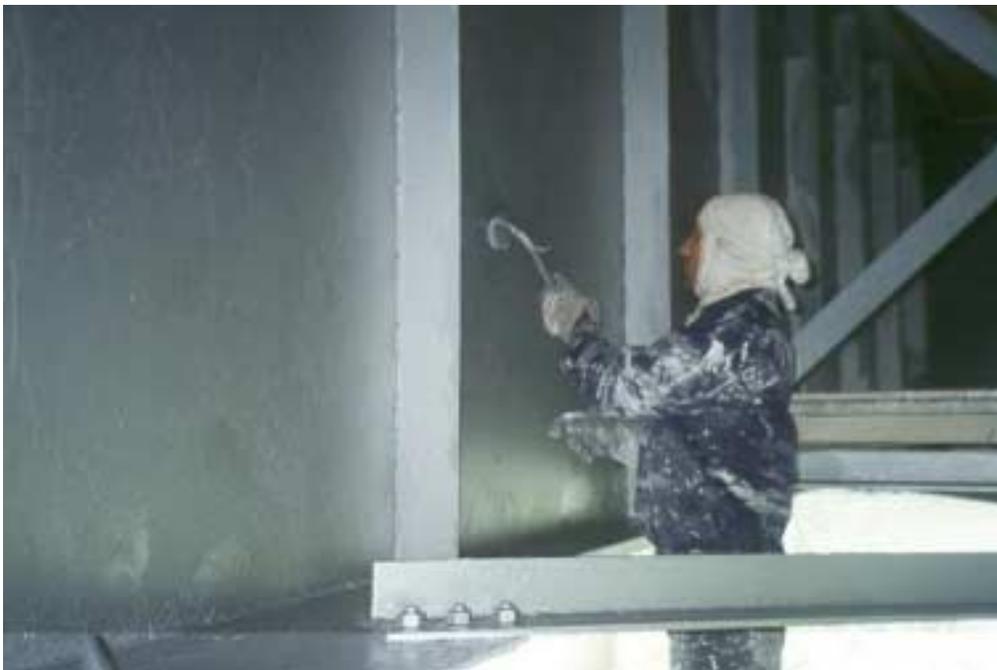
Painters working on spans 1 and 2 used man-lifts to access the elevated steel. Brushing and rolling were used to apply the paint in a portion of span 2, away from the riverfront development work, that was not totally contained (Figures 30,31). Drop cloths were used in that area to prevent damage to municipal property from paint splatter. In span 1, the contractor assisted KYTC personnel with an experimental application of a micaceous iron ore pigmented MCU intermediate coating. That coating was applied experimentally on several panels (Figure 32). The contractor also supplied man lifts and personnel to test high-pressure water jetting (20,000 to 40,000 psi) in span 3.

Figure 30. Painter brush applying the intermediate MCU aluminum primer.

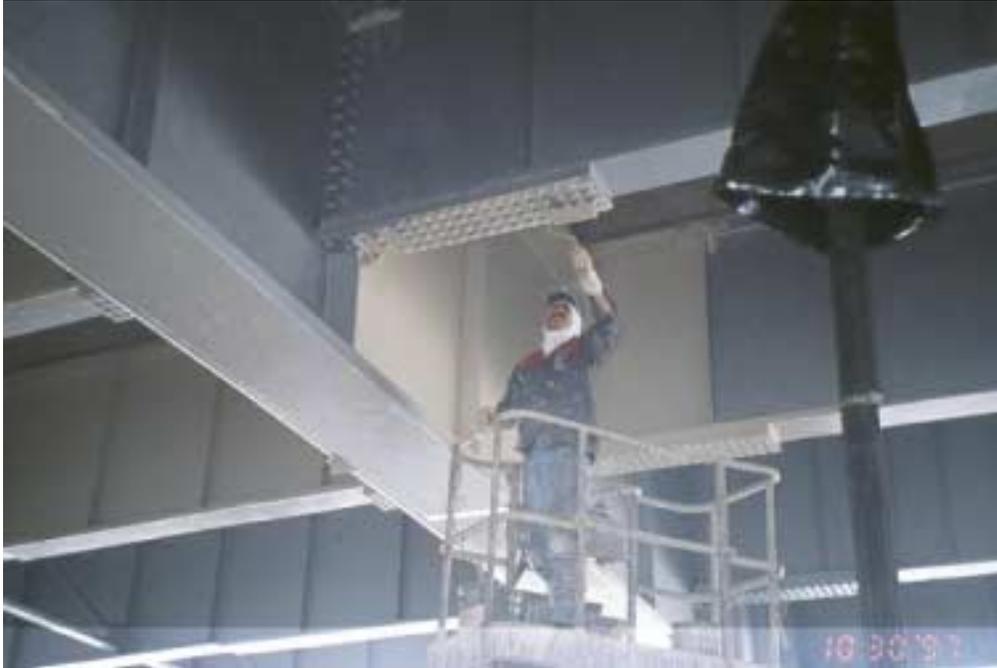
Figure 31. Painter applying the topcoat by rolling. Note the bag placed on the lamp post to protect it from dripping paint.

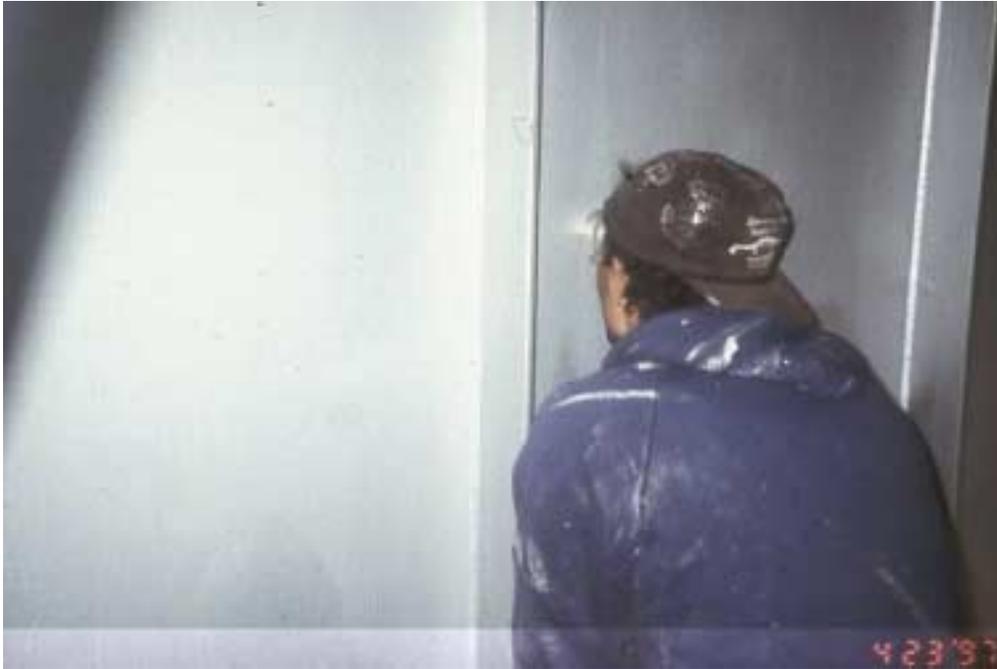
The QC/QA inspection procedure worked well. The contractor employed a QC person to inspect the completed work in a control area (Figure 37). In addition, he furnished his painters with tooth gages to inspect the wet film thickness as they were painting (Figure 38). The KYTC inspector performed the follow-on QA inspection in the control area. When a span, or a major portion of a span was completed, Division of Construction personnel followed with a final inspection. Once any touch-up needed work was performed, the contractor was paid. To facilitate the work, the Division of Construction inspector periodically traversed the accessible spans in a manlift with a painter to affect minor repairs as the final inspection progressed (Figure 39). That high level of cooperation speeded the completion of the work throughout the project.

Figure 37. Contractor performing QC inspection on intermediate coat using a Tooke gage.

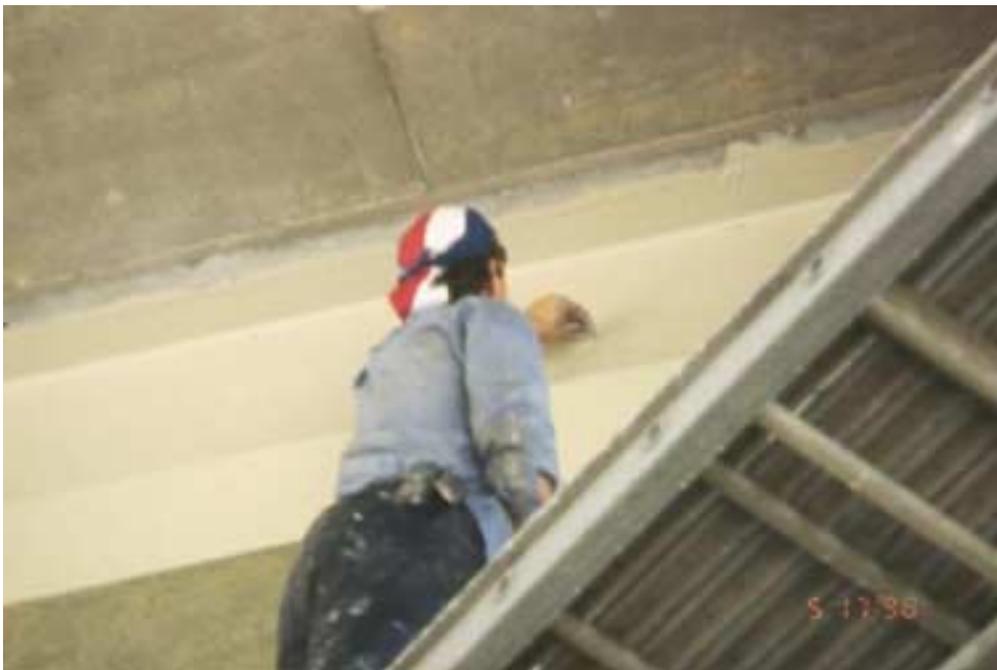
Figure 38. The KYTC QA inspector conducting wet film tests using a tooth gage. This was done at the span 4 overpass to facilitate the inspection process due to the need for traffic control on I 64.

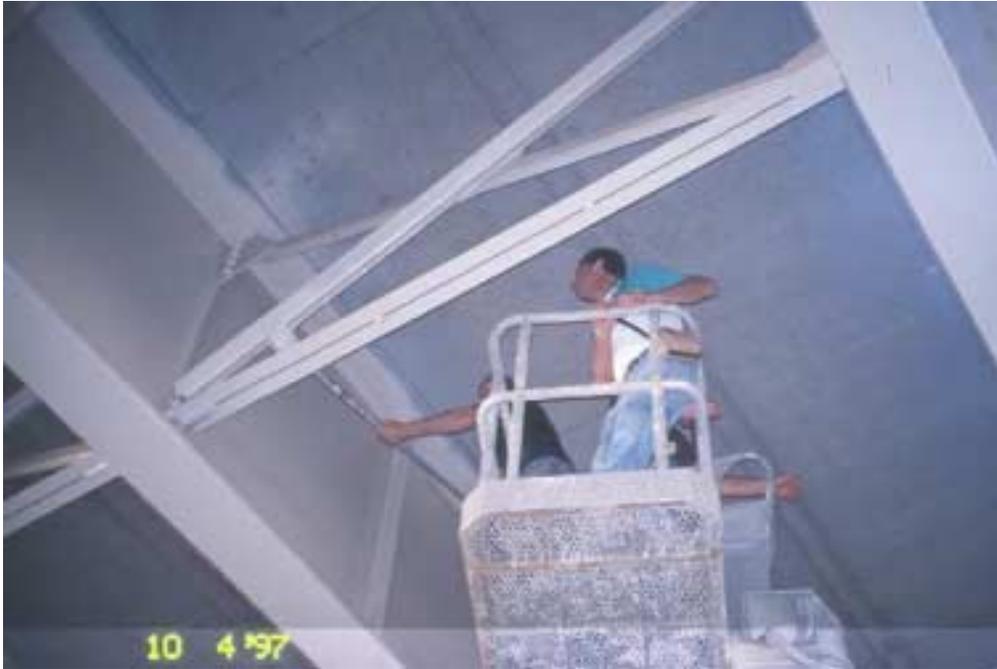
Figure 39. Concurrent final inspection and touch-up by the Division of Construction inspector and the contractor's painter using a self-propelled manlift.

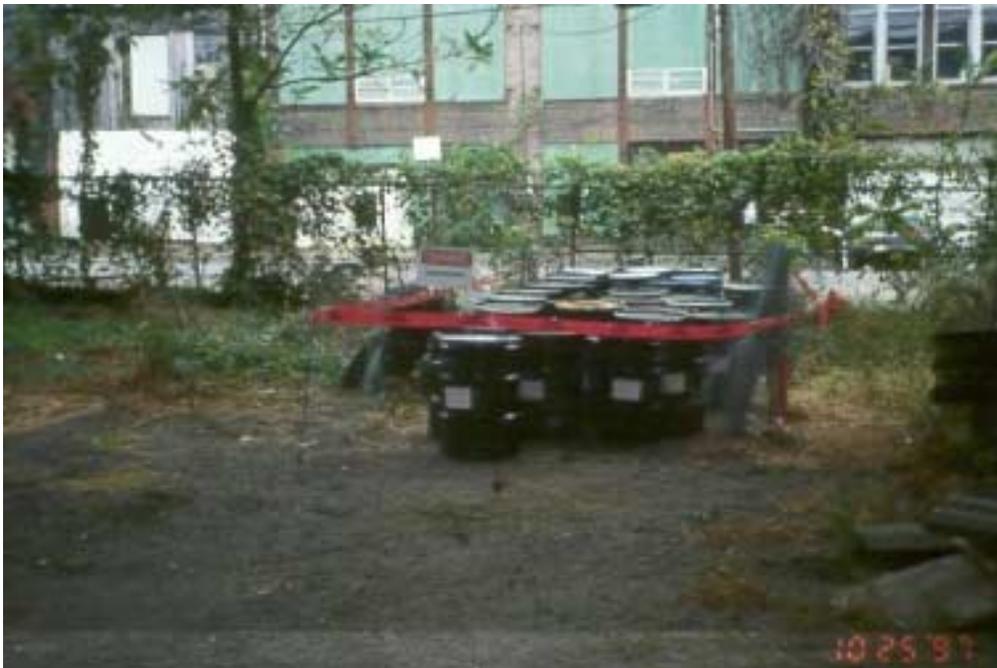
The hazardous waste collection and storage operation was equally uneventful. Only twenty-one 55-gallon barrels of hazardous wastes (paint debris mixed with rust) were generated during the entire project (Figure 40). The only problem that occurred was related to the failure of the contractor to dispose of some of the wastes within the 90-day interval mandated for large-quantity generators.

Figure 40. The hazardous waste storage site located in a locked KYTC compound.

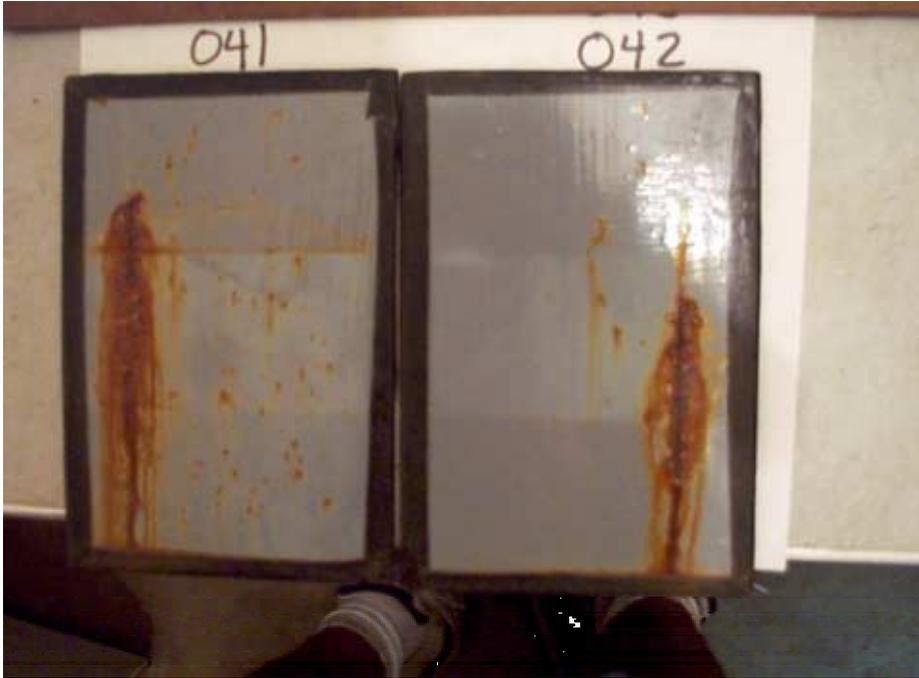
The tests were run for seven 6-week intervals or 7,056 hours (Figure 47). In part, the extended duration of those tests was due to the desire of KYTC and KTC personnel to gain familiarity with the procedure. No endpoints for coatings failure were established.

Figure 47. Typical panels after 7,056 hours testing

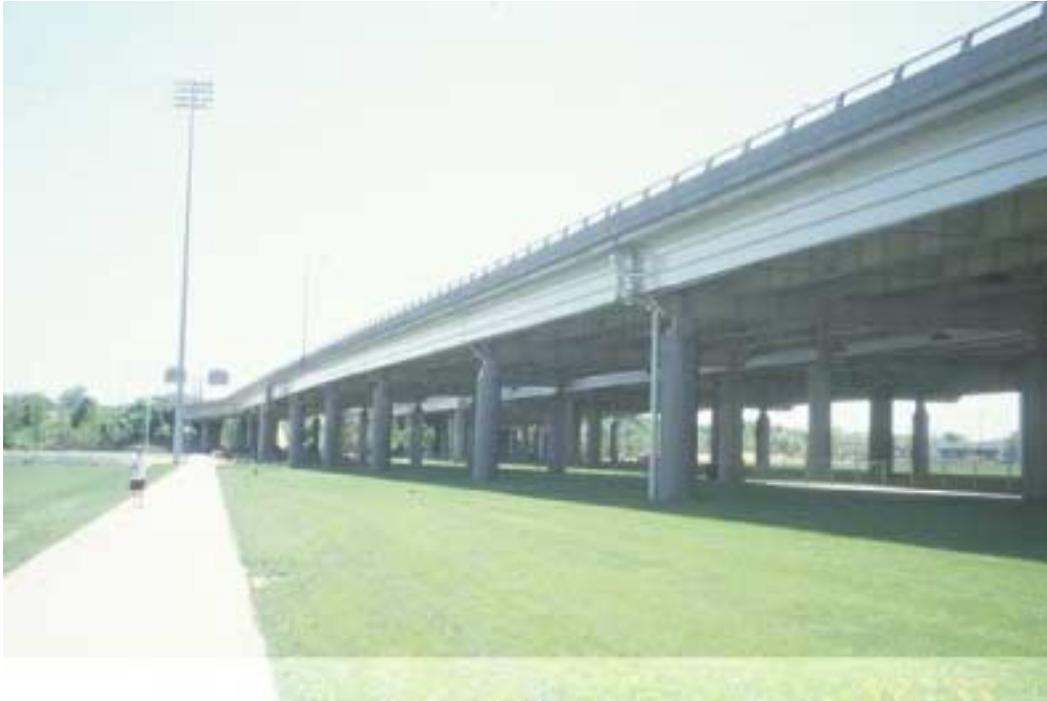
Figure 53. The east end of span 1 at the Riverfront Park in 1999.

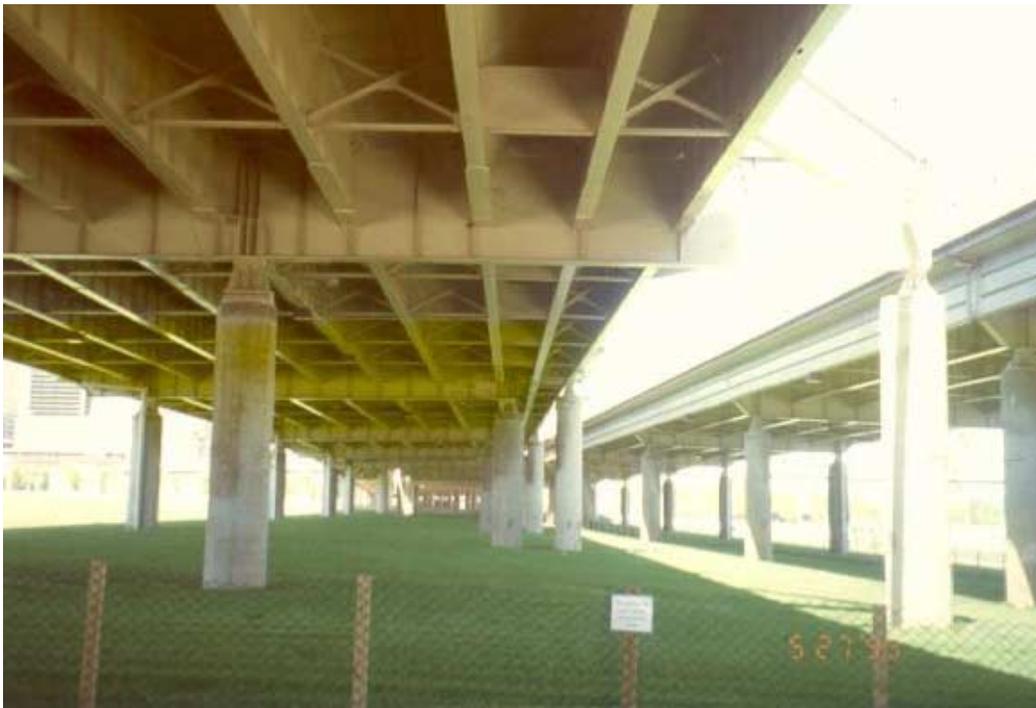
Figure 54. Span 1 viewed from the Riverfront Park looking westward in 1999.

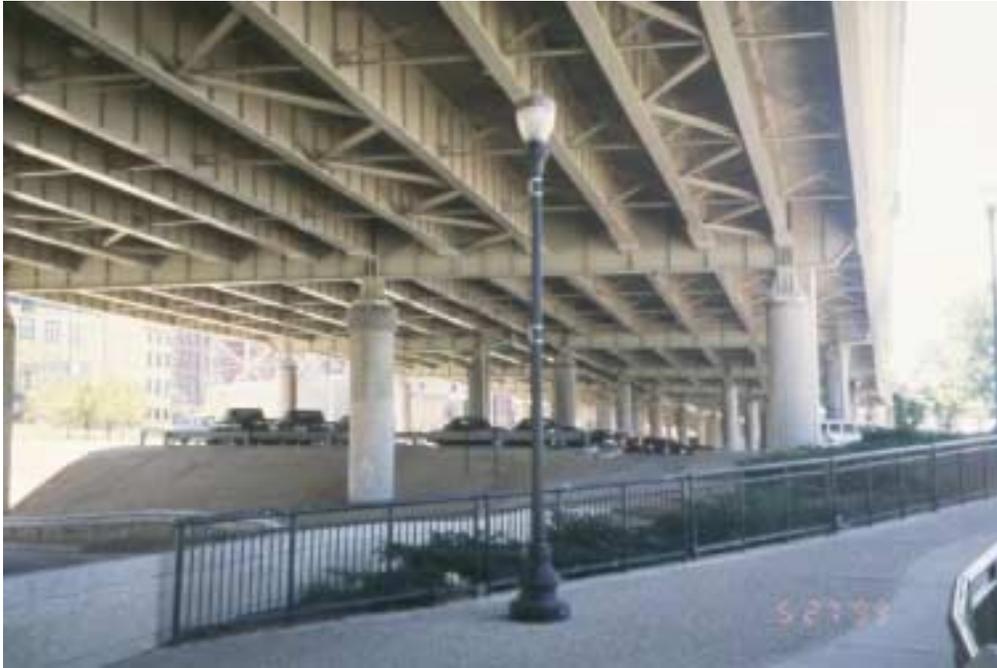
Figure 56. Completed span 2 near the GALT House in 1999.

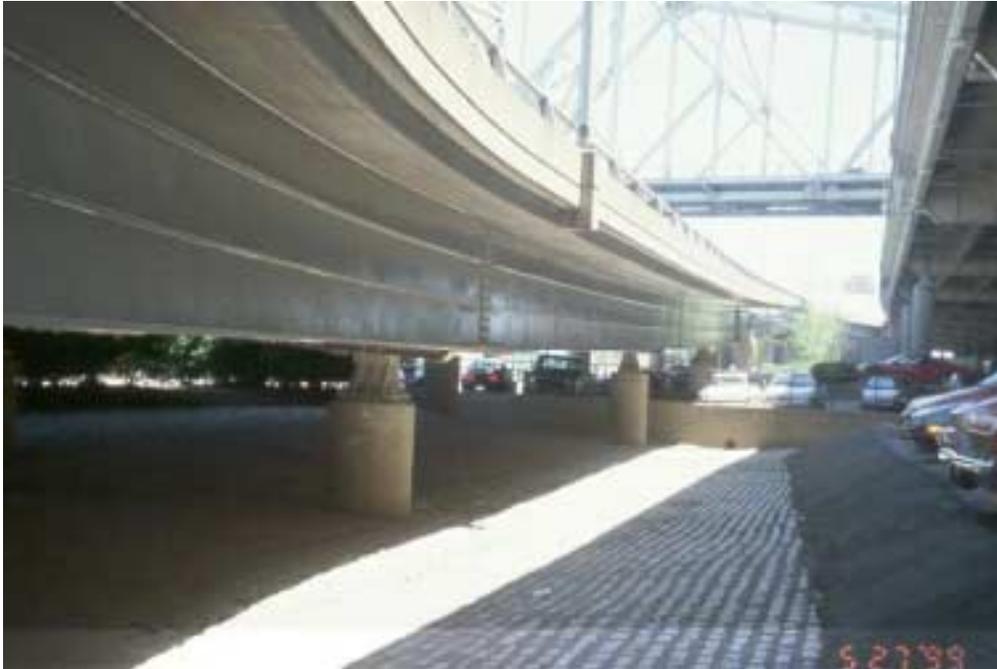
Figure 58. 3rd Street off ramp in span 2 in 1999.

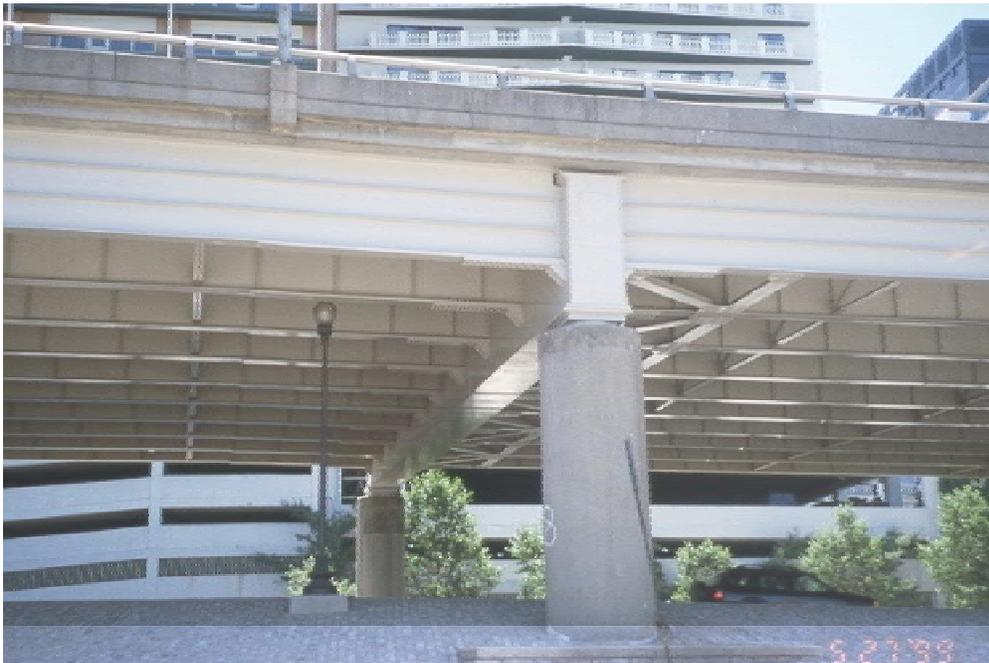
Figure 59. A typical view of the paintwork at the west end at the west end of span 2 in 1999.

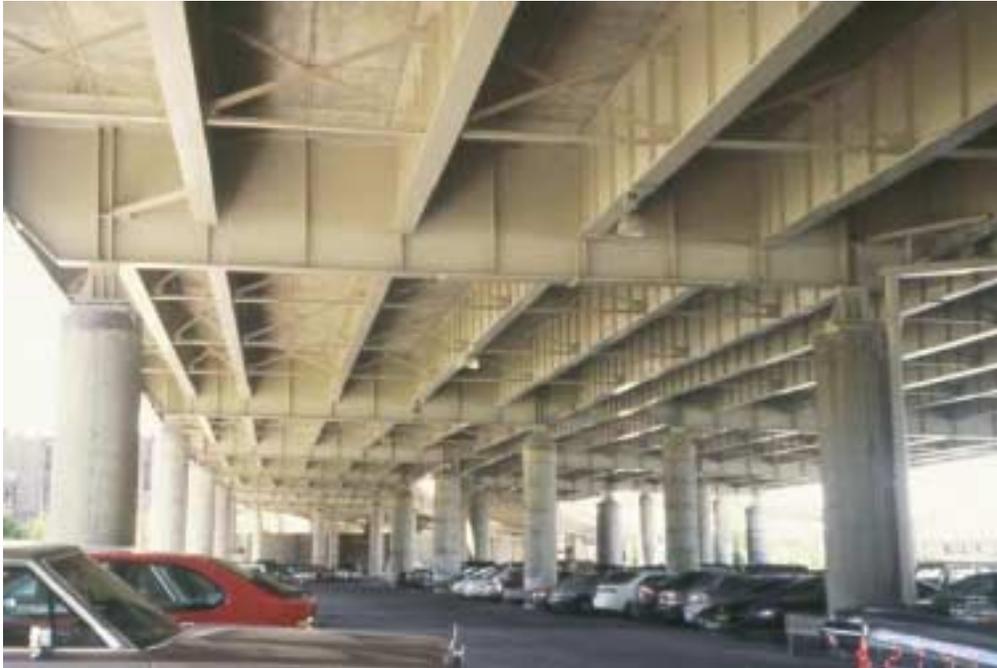
Figure 61. Westward view from a parking lot at east end of span 3 in 1999.

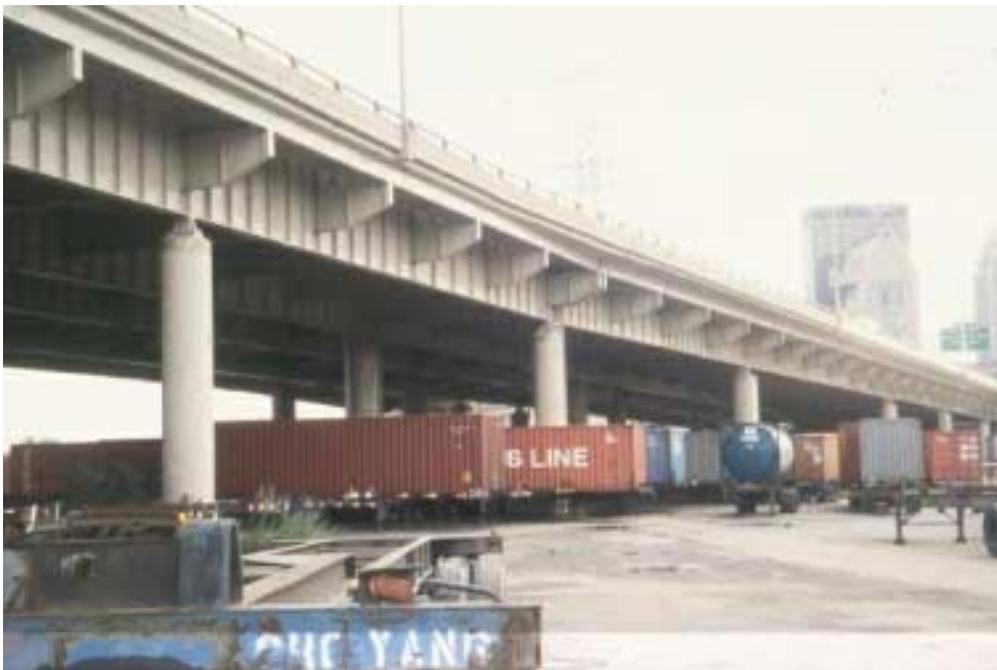
The condition of the paint was difficult to determine at the west end of Span 3. Span 3 ends over the cargo yard at 13th street. In the yard, there were a few small some spots including bolt heads where to topcoat had not been applied. There was a small amount of rust staining on the floor beams under the modular joints similar to the one observed in the parking lot. A drain on exterior of westbound lane was clogged with grass growing on it.

Figure 62. Eastward view from west end of span 3 over cargo yard in 1999.

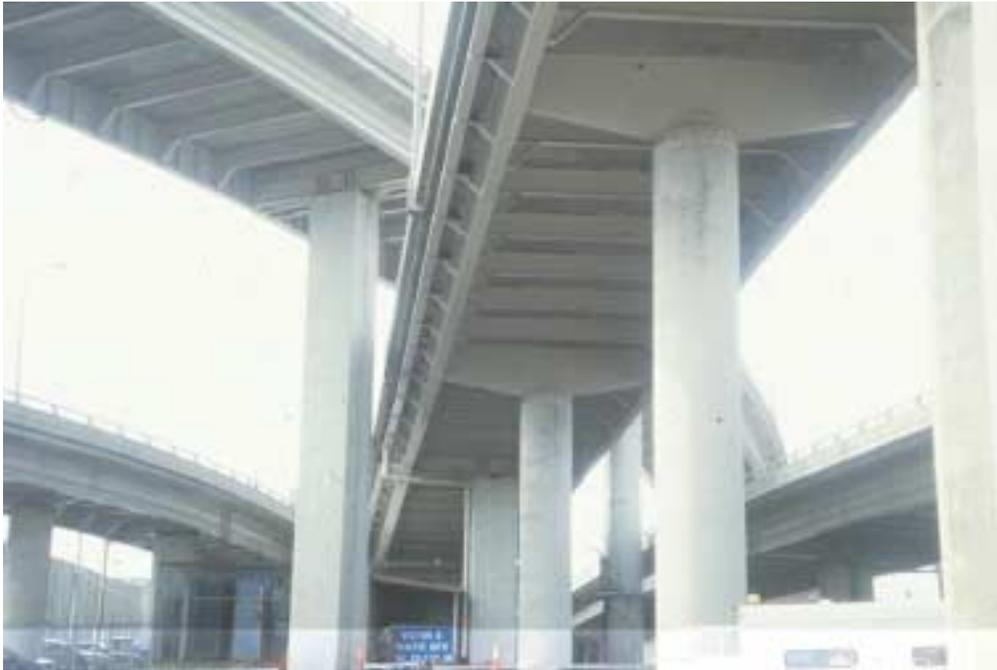
Tooke gauge readings indicated 4 mils DFT of primer and 3 mils DFT of topcoat. The 9th street interchange had very little rusting at the joints. The abutment bearings at 9th street were in very good condition with no rust. Pinpoint rust and spot rusting was present on the edges of flanges at a few locations, mostly below modular joints. There were few missed spots of topcoat and few holidays on the stiffeners.

Figure 65. Paintwork on spans 4, 5, 6. and 8.

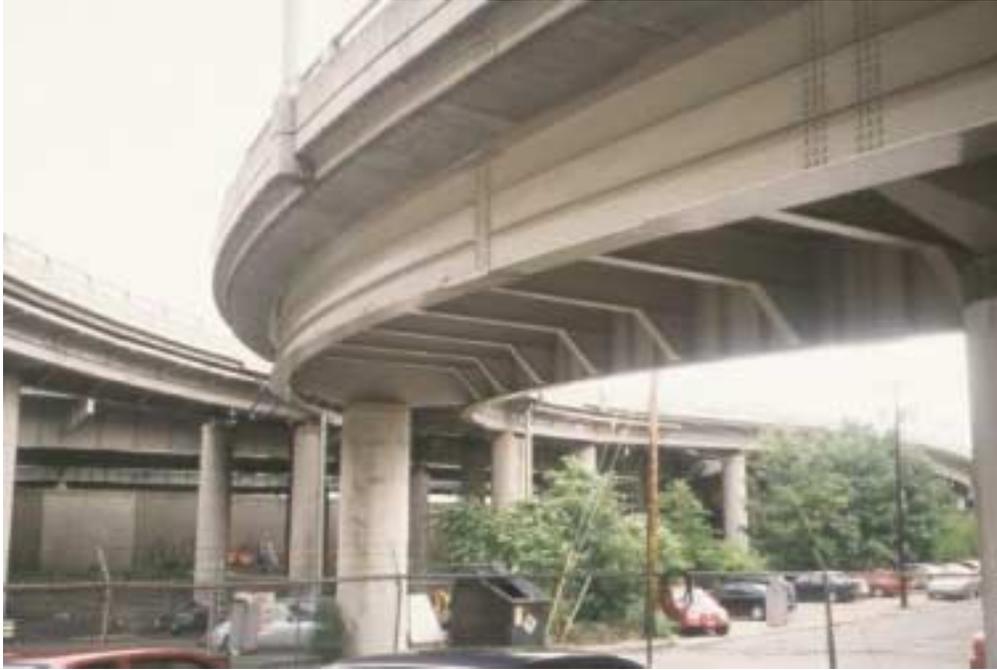
Figure 66. Span 7 from Main Street to east bound I 64 in 1999.

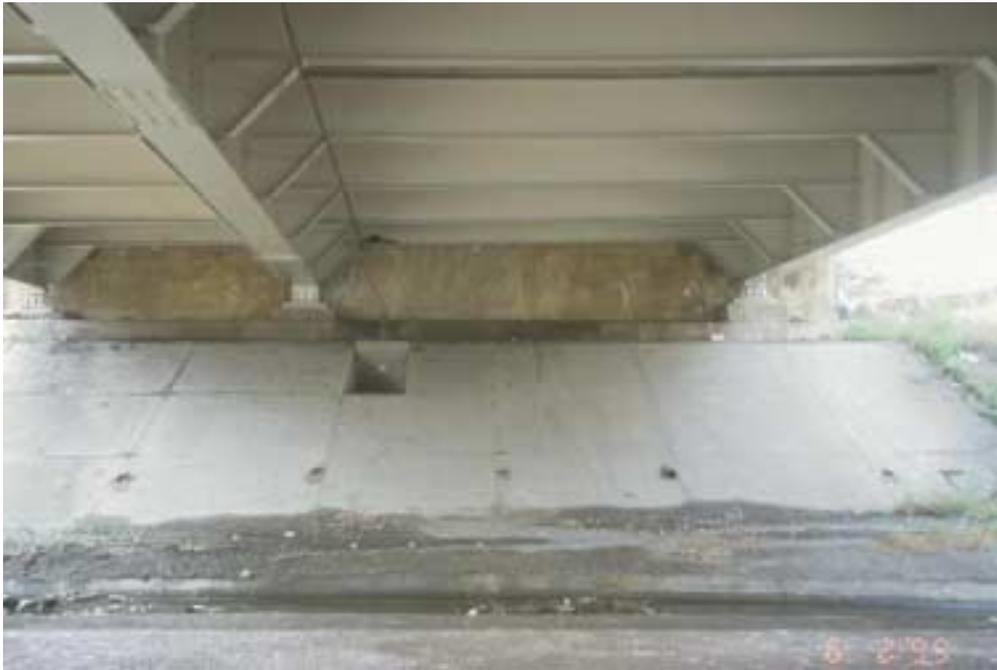
Figure 67. Rocker assemblies and end of span 6 at 9th Street in 1999.

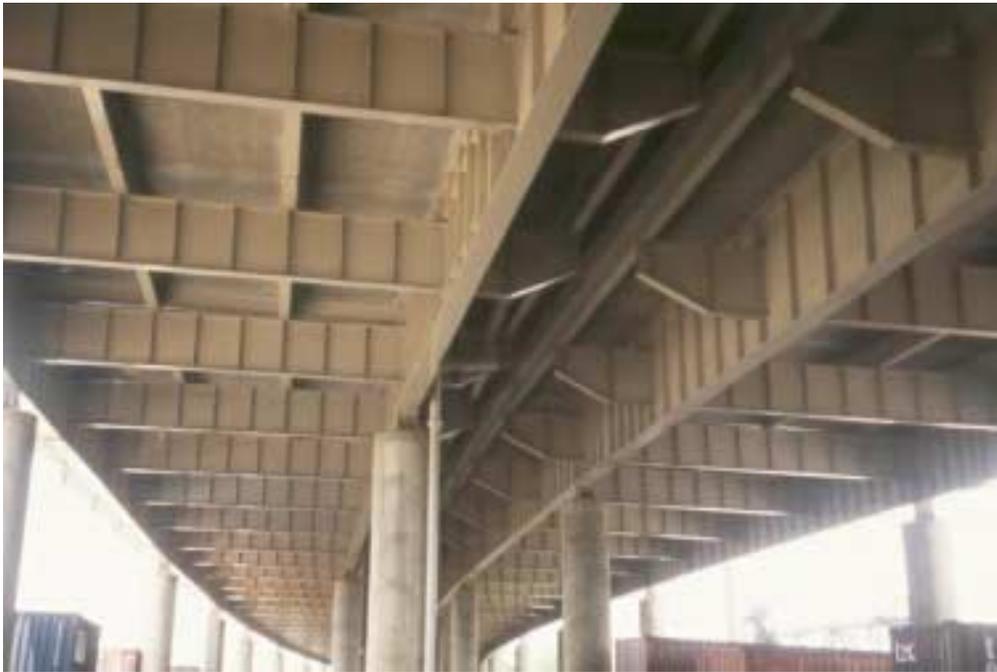
Figure 69. View of span 9 from the east end looking westward in 1999.

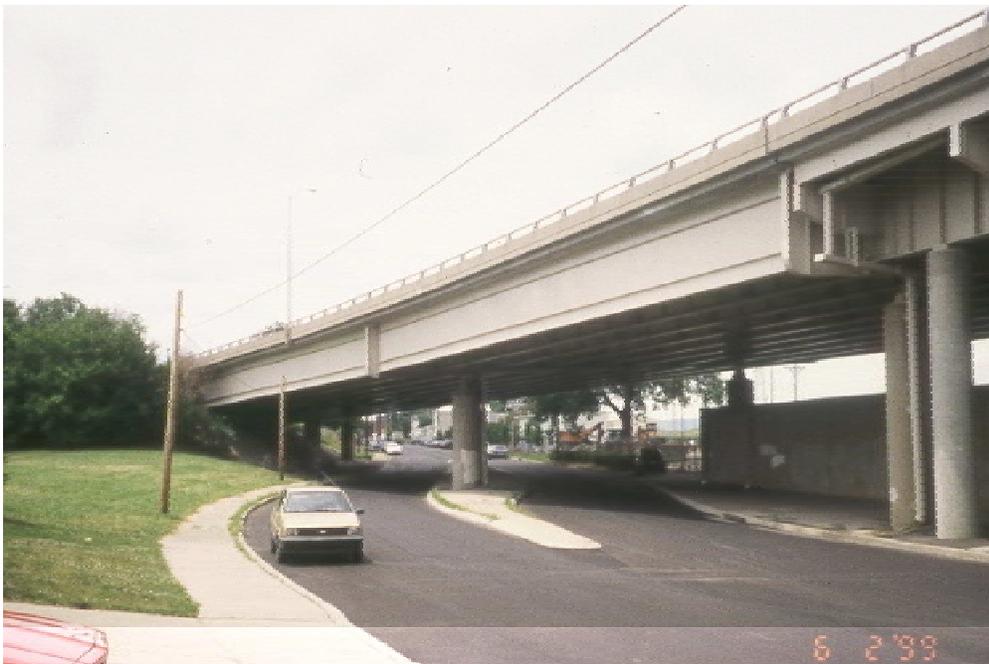
Figure 70. West end of span 9 looking eastward in 1999.

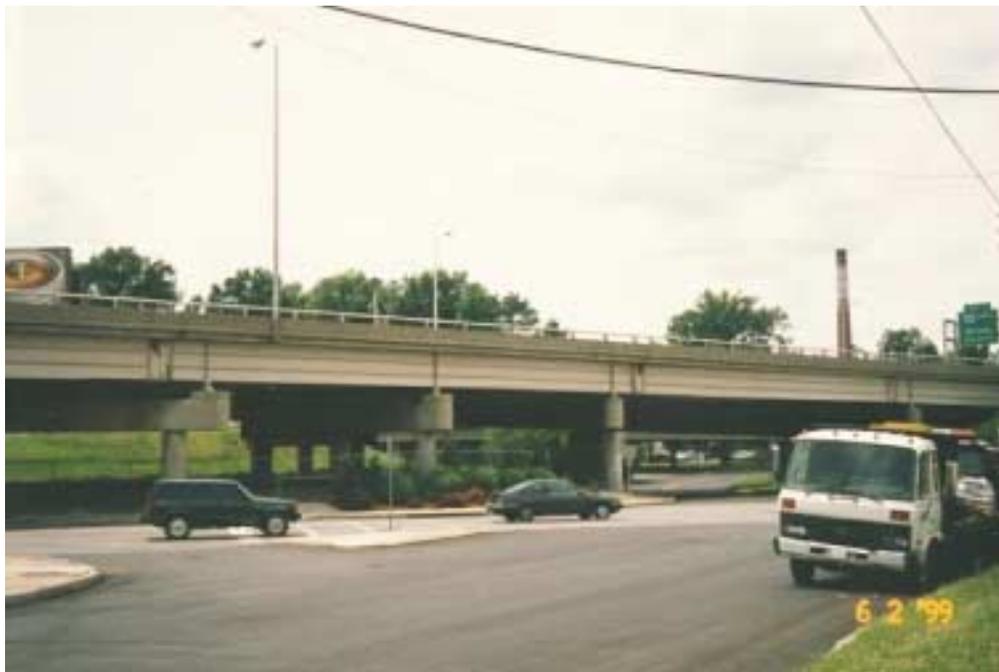
Slight rust was found under a poured joint (narrow joint) and the joint was leaking. There were rust spots on exterior where cleaning was not performed properly. There were rust stains coming through on some back-to-back angles. A small amount of rust was found on bearings and pads at east abutment. A small amount of corrosion was found on steel under two other poured joints. There were burn marks on the third beam at abutment bearings from a fire (vandals?). The bearing areas were in good condition. Tooke gauge readings taken at various locations on this span are given below.

Figure 71. Completed span 10 in 1999.

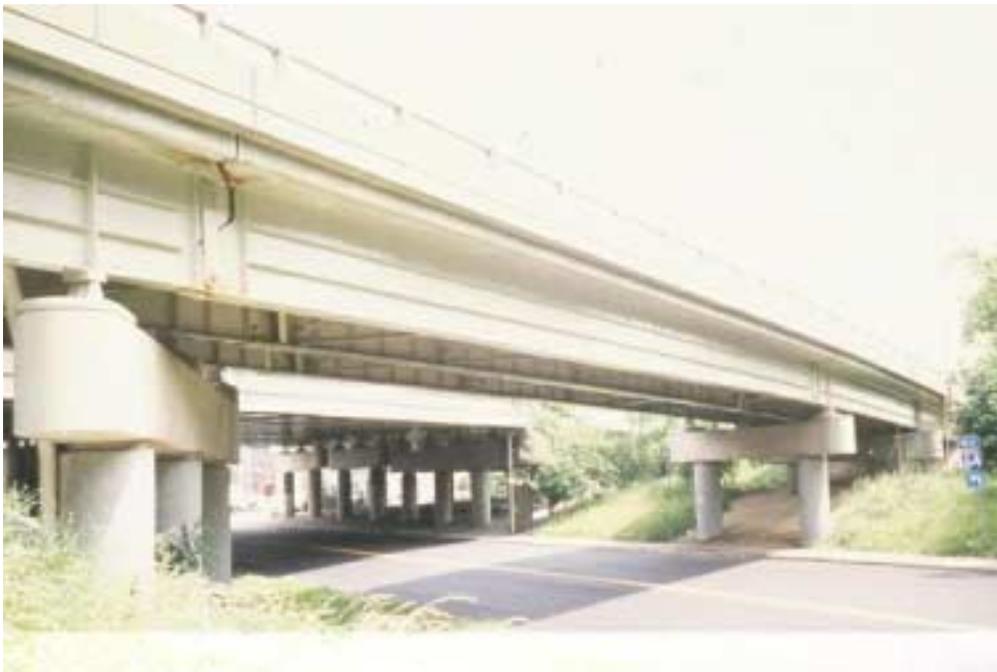
Rusting was found on pin and hangar joints at the west abutment. On the east abutment, there were rust spots and stains on back-to-back angle at some locations.

Figure 72. West-facing side of completed span 11 in 1999.

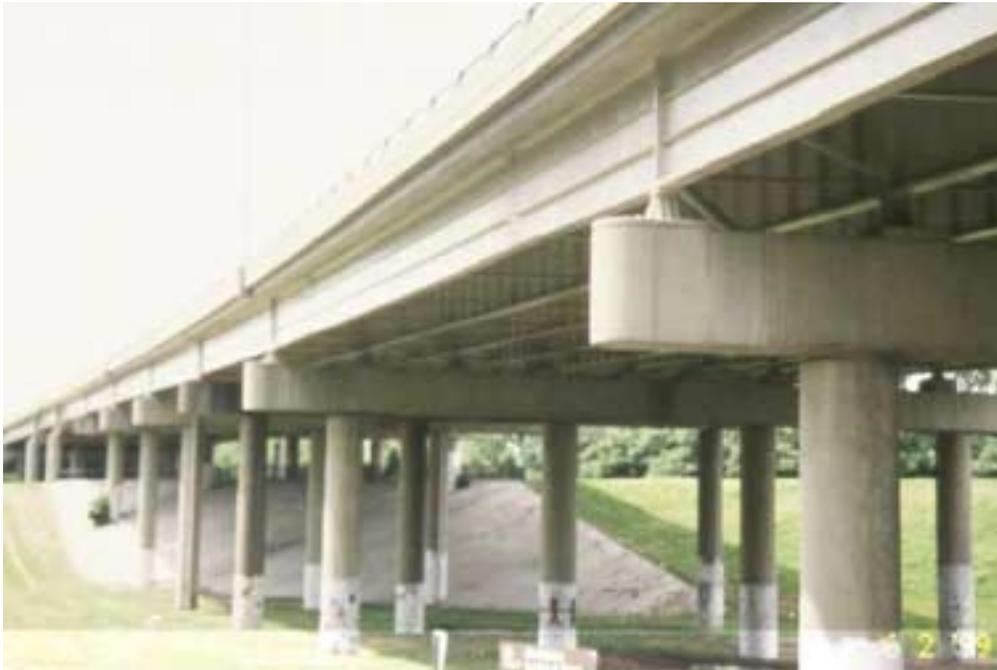
Figure 73. Westward view of completed span 12 from east end in 1999.

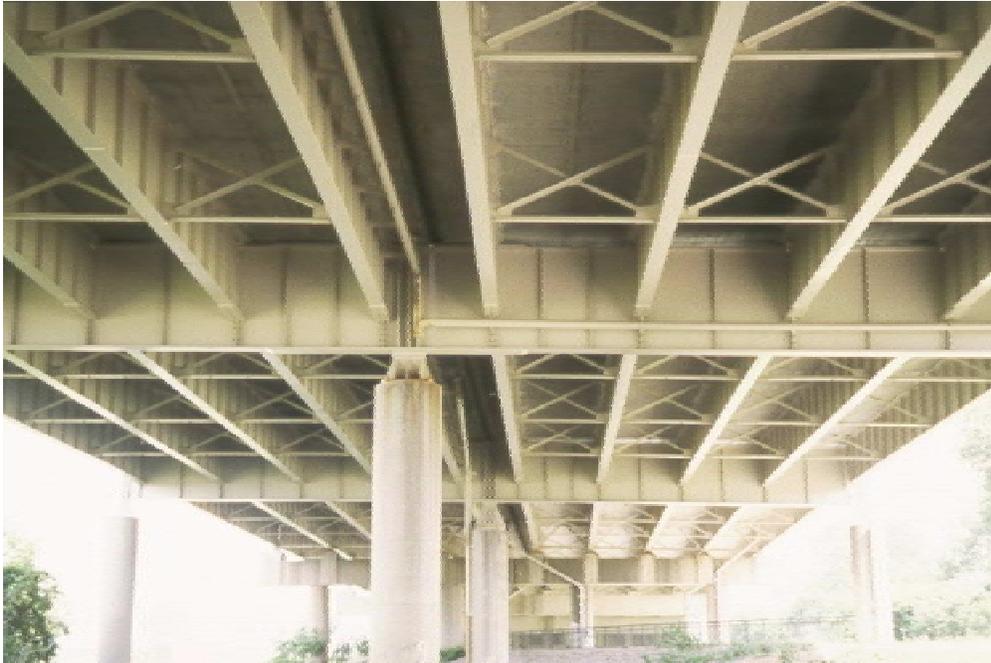
Figure 74. West end of span 12 looking eastward in 1999.

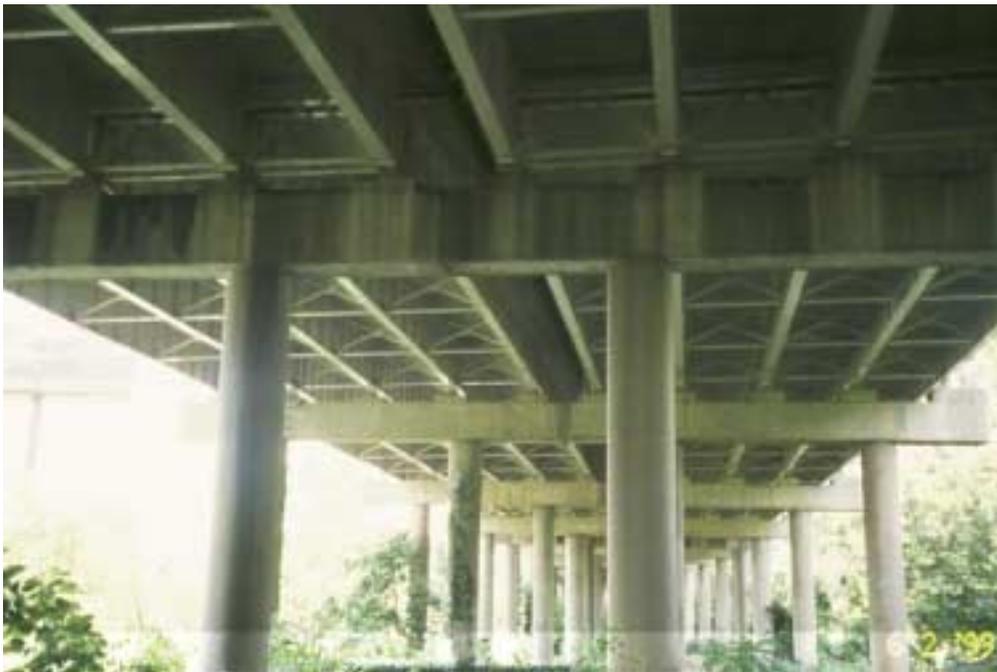
Figure 79. Westward view from the east end of span 13 in 1999.

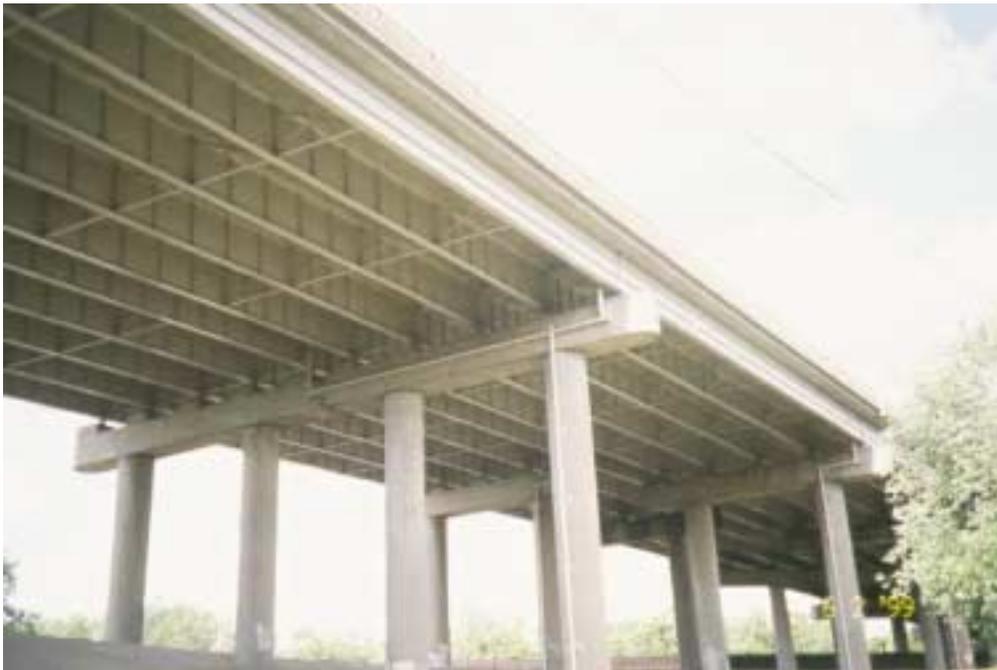
Figure 81. Completed west end of span 13 in 1999.
